APC Error

APC Postage Label Error

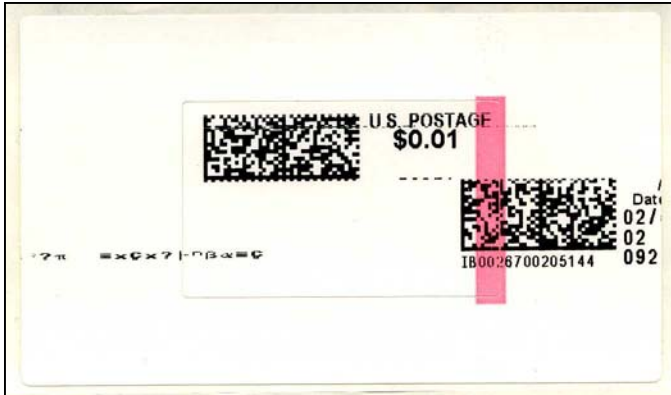
Thermal printers usually have a stationary print-head (unlike inkjet printers which rely on a print-head that moves across the paper as it advances through the printer).

Given that only the paper is moving through the printer, a left-right shift of the printed information should technically be impossible via physical movement of the paper.

It is the educated guess of the exhibitor that the shift in the printed information comes from an electronic “hiccup” (data stream corruption to the printer perhaps) whereby the printer was told to print the information further to the right. Notice also the “characters” to the left on the last row of information, consisting of unusual characters:

The kiosk must have corrected itself, as the next label printed (a 7¢ value) was printed normally.
